MSP430F5325 Device Erratasheet

1 Revision History

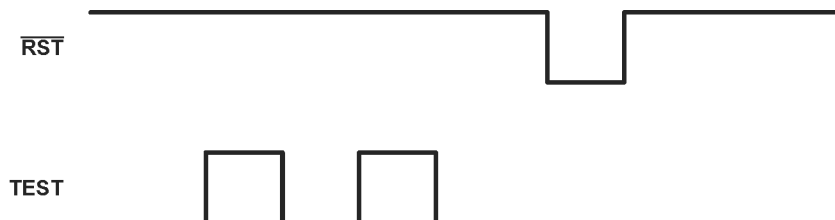
Function	BSL does not exit to application code
Description	The methods used to exit the BSL per MSP430 Programming Via the Bootstrap Loader (SLAU319) are invalid.
Workaround	To exit the BSL one of the following methods must be used. - A Power cycle or - Toggle the TEST pin twice when nRST is high and after 50us pull nRST low.

Note: This toggling of TEST pins is not subject to timing constraints. The appropriate level transitions on TEST pin, followed by a RST pulse after 50us, are sufficient to trigger an exit from BSL mode.
