MSP430F5632 Device Erratasheet

1 Revision History

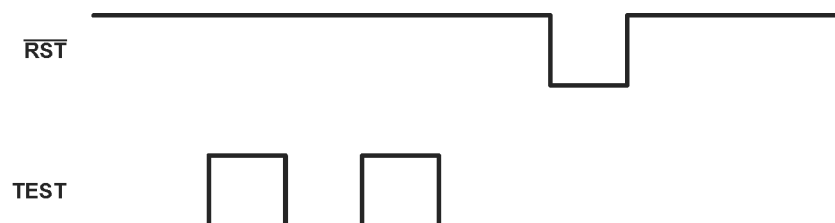
BSL does not exit to application code

The methods used to exit the BSL per MSP430 Programming Via the Bootstrap Loader ([SLAU319](#)) are invalid.

To exit the BSL one of the following methods must be used.

- A Power cycle

or

- Toggle the TEST pin twice when nRST is high and after 50us pull nRST low.

Note: This toggling of TEST pins is not subject to timing constraints. The appropriate level transitions on TEST pin, followed by a RST pulse after 50us, are sufficient to trigger an exit from BSL mode.
